Derailment of freight train 6DA2

near Marryat, South Australia | 26 July 2014

ATSB Transport Safety Report
Rail Occurrence Investigation
RO-2014-014
Final – 28 October 2015

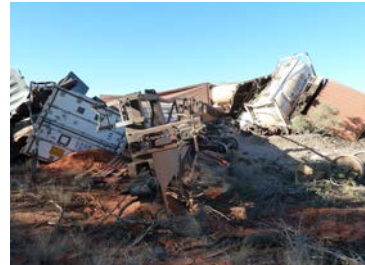
Derailed freight vehicles

The train was travelling at about 80 km/h when it derailed. The trailing locomotive, crew van and 17 wagons derailed, with the train separating into two portions that came to a stand about 108 m apart. The wagons (consisting of 35 platforms) and 340 m of track were significantly damaged.

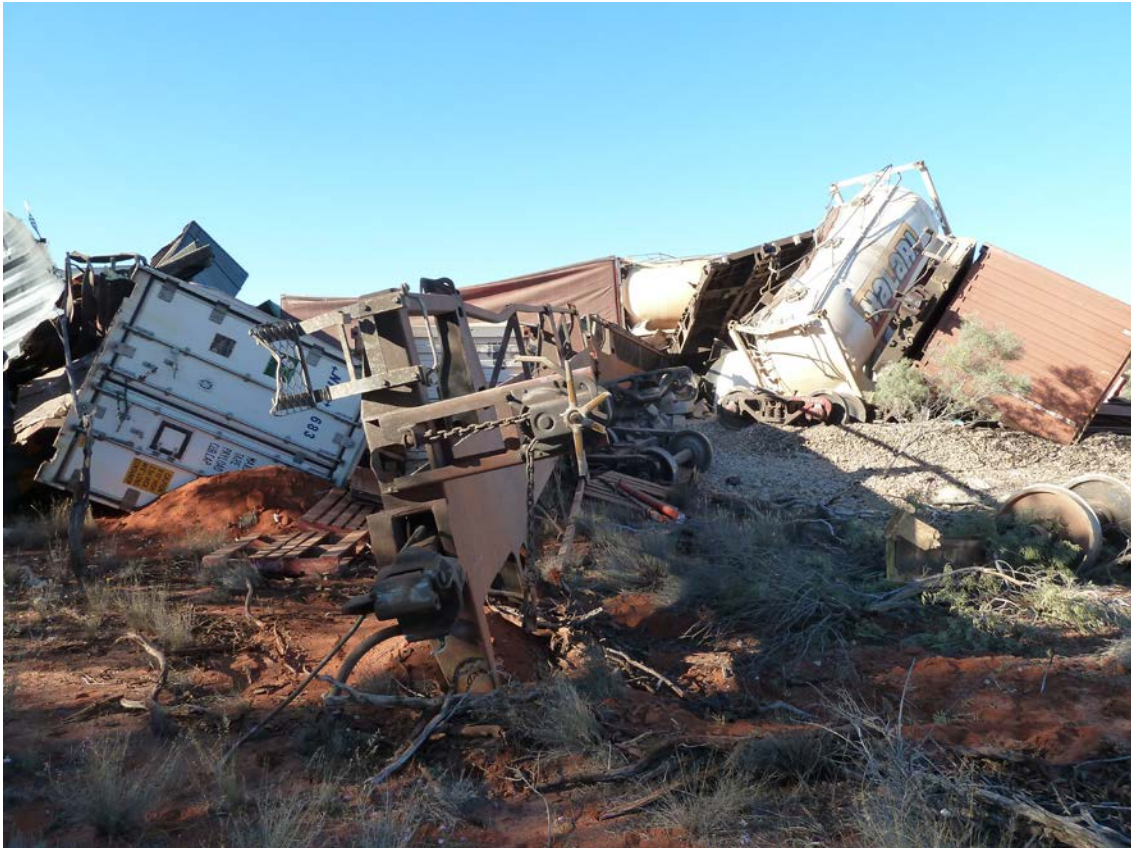
Figure 2: Derailed wagon and wreckage about 100m from the point of derailment

The rail vehicles and about 340 m of track infrastructure had sustained significant damage.

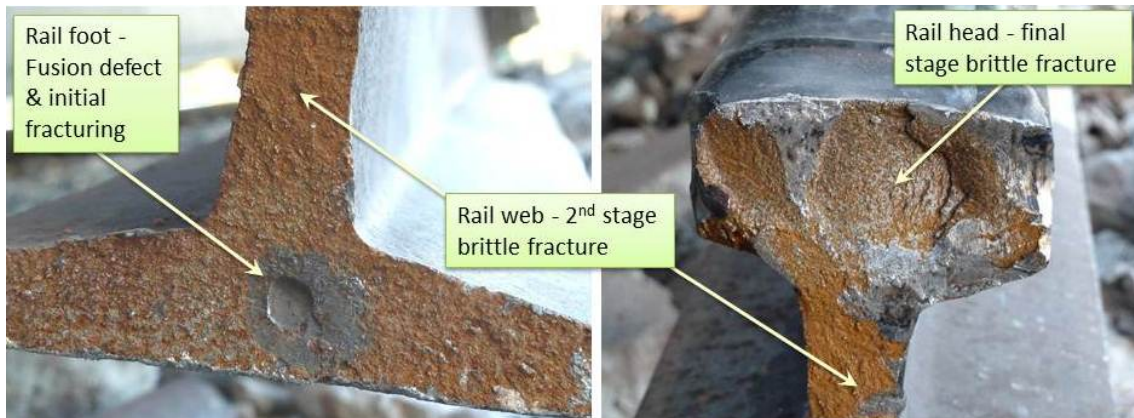
Figure 4: Flash-butt weld fusion defect and brittle fractures

The fractured flash-butt weld contained a fusion defect at the bond line in the rail foot. Differences in the surface condition over the remaining regions of the fracture indicated that failure of the weld occurred progressively, commencing with some initial cracking of the region surrounding the weld defect (possibly immediately following the welding process, and while the weld was cooling to ambient temperature).

A second stage of cracking occurred over the remainder of the foot and most of the web at some unknown time prior to the date of the derailment. The final stage of cracking occurred over the remaining uncracked region in the centre of the head. The second and subsequent stages of failure involved brittle fracture.

Figure 4 illustrates the fusion defect through failed flash-butt weld region. The defect was present below the web of the rail foot and presented as a depression measuring 8 mm wide by 10 mm high. A surrounding darker region measuring 18 mm in diameter was consistent with pre-existing cracking and subsequent crack surface degradation.

Metallurgical analysis (by IRT) of the weld heat affected zone suggested that the defect most likely formed as a fusion-line flaw when the joint was flash-butt welded (between 1975 and 1980). Analysis also suggested that the quality of this weld would not meet the specifications of the current Australian Standard, AS 1085.20 - *Railway track material - Welding of steel rail*. The presence of the fusion defect ultimately led to the failure the flash-butt weld at the bond line. The fracture surface immediately surrounding the weld defect was 'extensively degraded' and most likely developed in the immediate post-weld cooling period.

Second-stage cracking was by brittle fracture over the remainder of the foot and most of the web (Figure 4), however the crack growth rate and interval before the derailment of train 6DA2 could
